EFFECT OF HYDROPHYTES ON THE PERFORMANCE OF SECONDARY CANAL; YAR HUSSAIN MINOR, SWABI- KHYBER PAKHTUNKHWA, PAKISTANSaiful Islam^{1*}, Muhammad Zubair Khan¹ and Haroon Khan²DOI: <https://doi.org/10.28941/pjwsr.v27i4.956>**ABSTRACT**

Keywords: Hydrophytes, performance of secondary canal; Yar Hussain Minor**Citation:** Islam, S; M.Z. Khan and H. Khan. 2021 Effect of Hydrophytes on the Performance of Secondary Canal; Yar Hussain Minor, Swabi- Khyber Pakhtunkhwa, Pakistan. Pak. J. Weed Sci. Res., 27(4): 565-576.

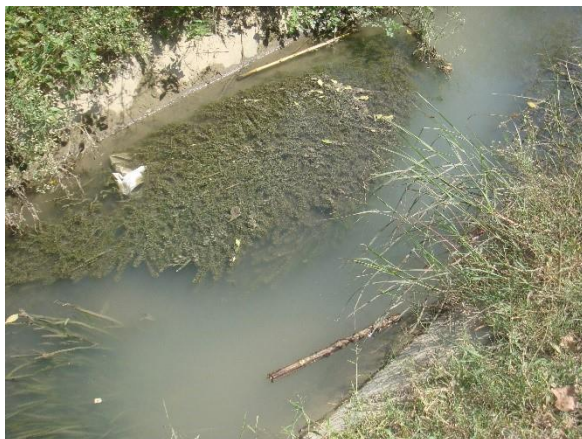
(a) Hydrophytes in canal (Direct impact)

In the YHM, the hydrophytes growing can be termed as aquatic weeds, which can be broadly defined as "undesirable plants growing in aquatic environment (Lawrence, 1966). The hydrophytes growth in canal can reduce velocity, raise water level, cause deposition of sediments (Fig. 3a) and

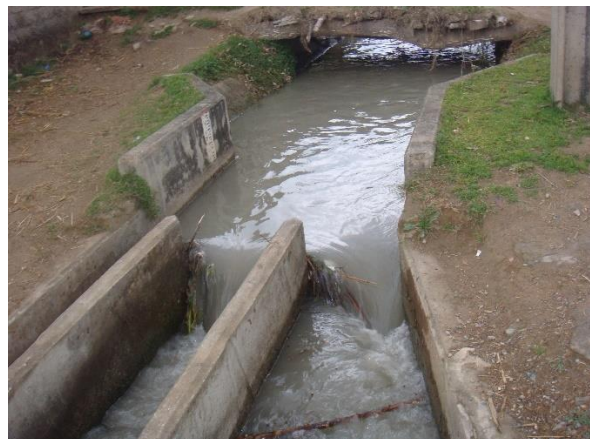
(b) Detached hydrophytes stuck at outlet

Fig. 3: Hydrophytes in the secondary canal and the outlet

Indirectly these hydrophytes detached and stuck with bifurcation wall of weirs and reduced width of outlets. Therefore, daily discharges were determined with and without detached hydrophytes present at each outlet. The outlet width blocked by detached hydrophytes was measured daily by

when detached stuck in the weirs, affecting canal performance (Fig. 3b). Hydrophytes samples were collected and identified in Department of Weed Sciences and Botany, The University of Agriculture Peshawar. Five different species were found in the YHM (Fig. 4 a-e). The earlier studies also reported hydrophytes in water bodies of the same area (Fawad *et al.*, 2013)

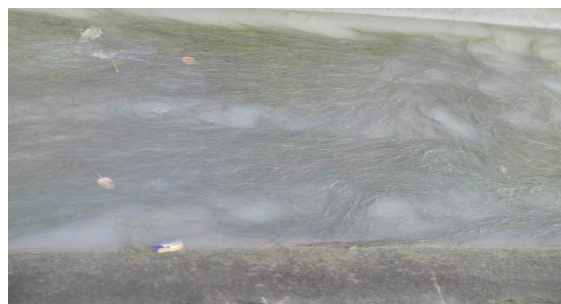
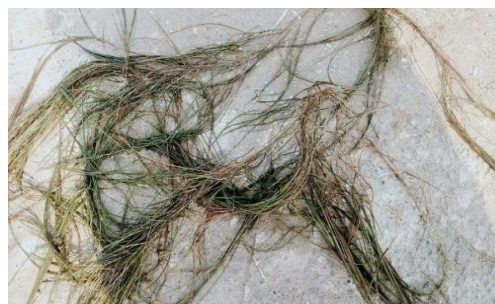
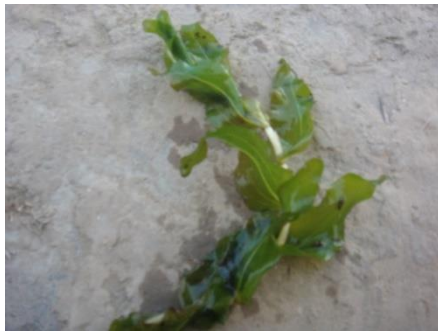
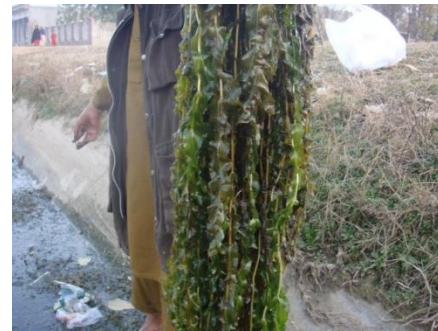
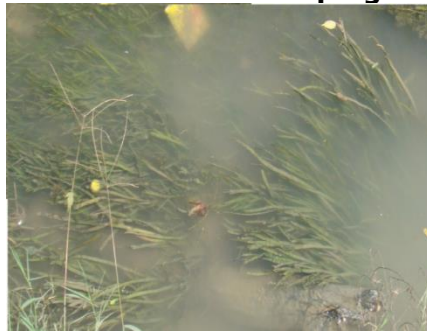
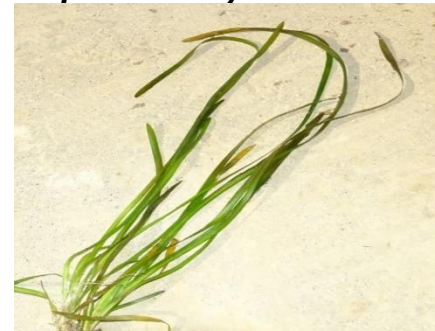
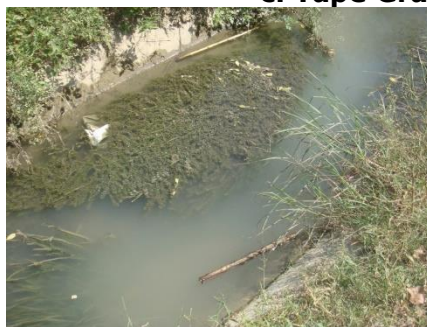
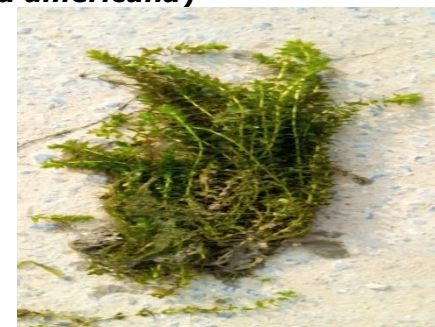
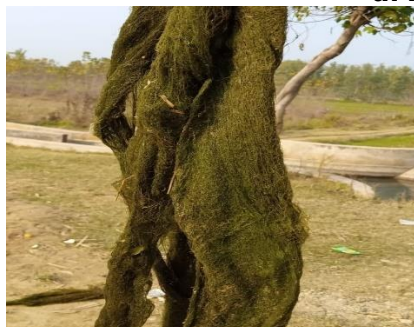
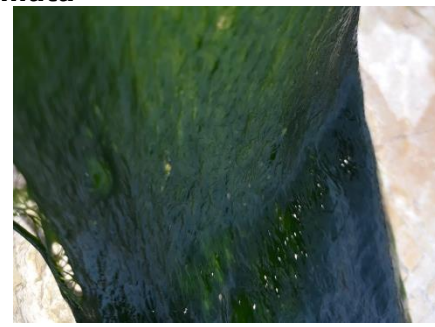
Fig. 4: Hydrophytes species found in YHM

a. Sago Pondweed (*Stuckenia Pectinata*)

b. Clasp Leaf (*Potamogeton perfoliatus*)

c. Tape Grass (*Vallisneria americana*)

d. *Hydrilla verticillata*

e. String Algae
