SEISMIC DESIGN CHARACTERIZATION OF RC SPECIAL MOMENT RESISTING FRAMES IN PAKISTAN-FIELD SURVEY TO LABORATORY EXPERIMENTS

ABSTRACT

Key Words: *Building stock survey; Quasi-static testing; Beam-column connections.*

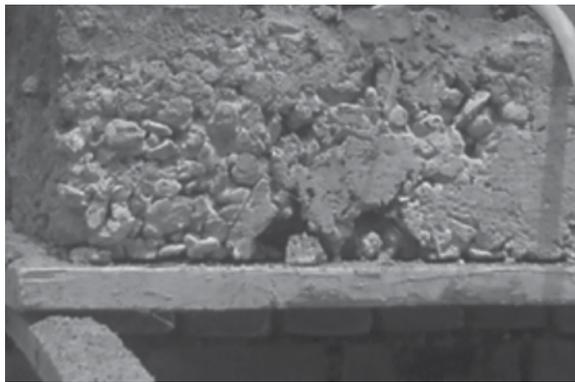
1. Compressive strength of concrete is about 30% less than the specified values. This implies that the minimum specified concrete compressive strength of 3000 psi, when cast in field, is in tune of 2000 psi (Figure 1).

Figure 1. Honeycombed cast concrete.

1. The compressive strength of concrete achieved on construction sites is about 30% less than the specified values.
2. Spacing of stirrups in beams and ties in columns is staggered and err approximately 50%, on the higher side from the design specifications.
3. Majority of ties and stirrups are close-ended with 90° bends instead of 135° seismic hooks as specified in design specifications.
4. Lap splices are provided in columns near the

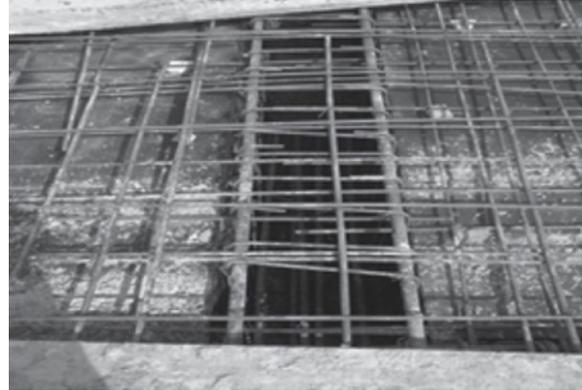
2. Spacing of stirrups in beams and ties in columns is staggered (Figure 2) with an error approximately of 50%, on the higher side.
3. Majority of ties and stirrups are close-ended with 90° bends instead of 135° seismic hooks (Figure 3) as specified in design specifications.

Figure 2. Staggered spacing of stirrups in beams.

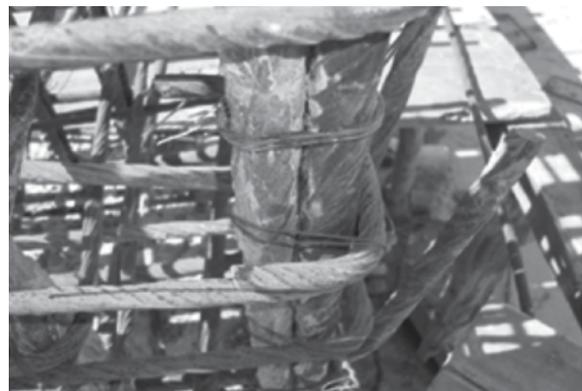
Figure 3. Insufficient hook length of ties in columns.

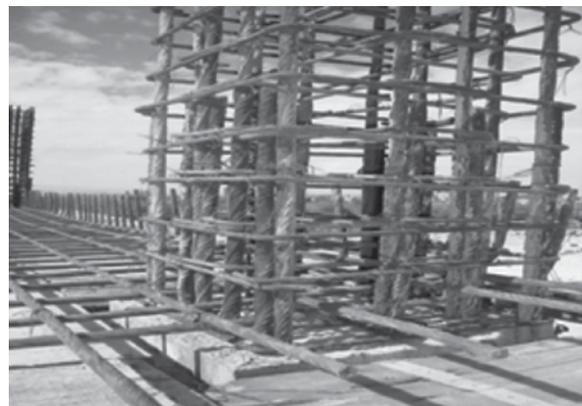
4. Lap splices are provided in columns near the beam-column connections contrary to the design specifications (Figure 4) which specify their provision at the point of contraflexure. Moreover, length of these splices is not according to the codal values but much less than what is specified by the code.

Figure 4. Improper location of lap-splices.

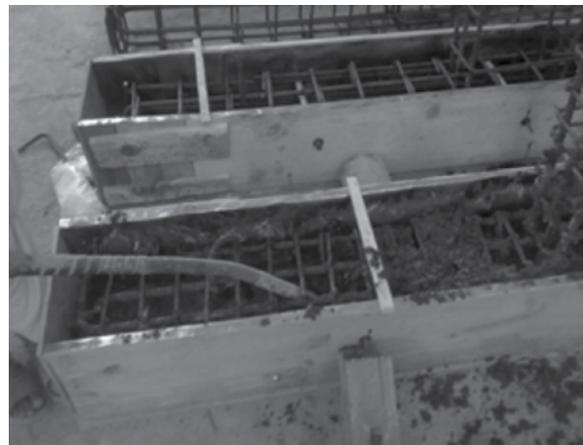
Figure 7. Placement of concrete in formwork with proper compaction through mechanical vibration.

All the models were constructed keeping in view the prevalent construction practices for reinforced concrete buildings in Pakistan. Timber formworks were prepared for casting of the model, however, to avoid loss of slurry during placement of concrete, the inner side of the formwork were lined with steel sheets. This also helped in achieving straight faces of concrete without any honeycombing or any other undesirable effect on quality of concrete. Subsequent to preparation of the models, concrete was cured for a period of 14 days by wrapping them up in hessian cloth and keeping them moist. Various stages of the specimen construction are portrayed in Figure 6 and Figure 7.
